Supersession Alternator belt pulley 535 0117 10 by Over-Running Alternator Pulley 535 0105 10

Dacia, Renault

Issued 11.2008

INA 0026

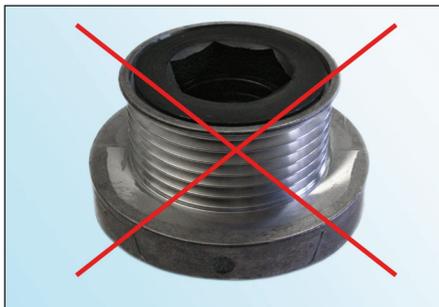
Fig. 1: 535 0117 10

The alternator belt pulley 535 0117 10 (Fig. 1) is no longer available and has been replaced by over-running alternator pulley 535 0105 10 (Fig. 2).
