febiEXAKT

Chain Tensioner

febi no. 26751

to fit
Mercedes-Benz M271 engines

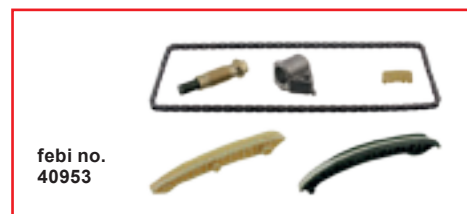
The manufacturer has modified the design of the chain tensioner. The version of the chain tensioner originally fitted (Repl. no. 271 050 04 11) has a non-return valve. In the new modified version (Repl. no. 271 050 06 11, the non-return valve has been removed (see Fig. 1).

To prevent the problem described above, febi bilstein recommends that the bracket be replaced as well when the chain tensioner is exchanged for the new version. febi bilstein offers two kits (febi 40953 and febi 40954) which include the bracket with integrated non-return valve.

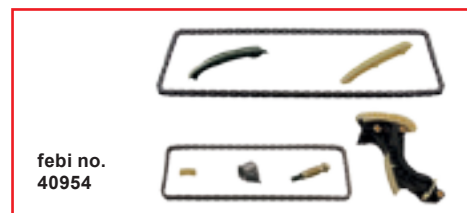
The chain tensioner is screwed into the bracket which incorporates a non-return valve (see Fig. 2). This valve controls the volume of oil so that the piston of the chain tensioner is constantly supported by the oil pressure should the oil pressure fluctuate.

If the non-return valve in the bracket does not work correctly, the oil is always able to flow back again. As a result, the chain tensioner cannot tension the chain correctly even though the chain tensioner has been refitted. This can lead to engine damage, especially when starting up and under heavy load.
