# VKM 15216 - VKPC 85624

## Technical Bulletin – March 2012

CHEVROLET, DAEWOO, OPEL, SAAB, VAUXHALL

### T0139

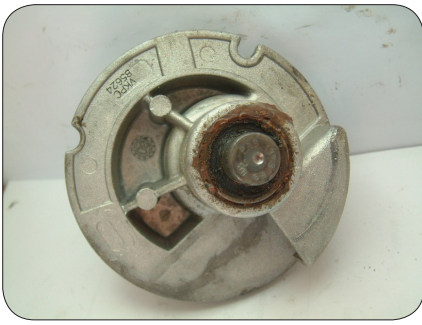
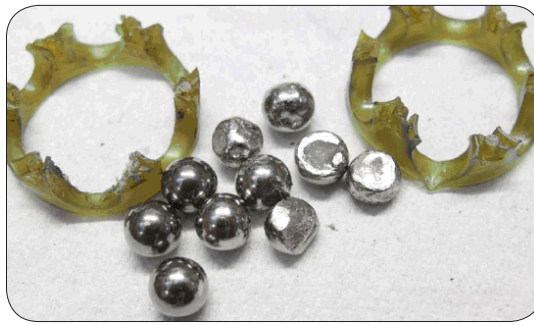
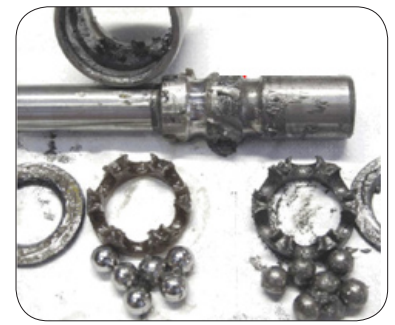
Over-tensioning the belt system will cause failure of the water pump first - as this component is the most affected by incorrect fitting.

Examples of a damaged water pump:

- Failure of the water pump pulley.

- Over-tensioning of the timing tensioner.
- Incorrect fitting of the timing tensioner.

The tightening torque of the tensioner bolt (supplied with the tensioner) must be strictly adhered to – If the fitting instructions are not followed correctly, the tensioner back plate, the bolt or the water pump could be damaged or in severe cases even break.
