Regulating throttle: Damage caused by corrosion on Boxer, Daily, Ducato and Jumper

Vehicles:		Product: Regulating throttle (diesel)		
Citroën, Fiat, Iveco, Peugeot		PIERBURG no.	Replacement for*	Ref. no.*
Fiat/Iveco	Daily IV C15/C18/S18 Ducato 3.0 JTD	7.01754.10.0	7523D 7.01754.07.0	504105594; 504264089; 504345917; 71724299; 71724302
Peugeot	Boxer III 3.0HDi			163638
Citroën	Jumper 3.0 HDi			163671/163676

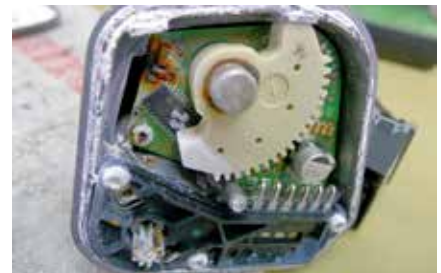
On the vehicles listed above, water or moisture may infiltrate through the coupling of the connecting cable. This moisture may cause severe damage in the interior of the regulating throttle, leading to eventual failure.

View of the interior of a damaged regulating throttle

Check whether there are visible traces of corrosion or moisture on the built-in plug of the regulating throttle or on the cable coupling. If this is the case, replace the regulating throttle and cable.

The regulating throttle 7523D installed until 2009 can be replaced by the PIERBURG regulating throttle 7.01754.10.0 using the adapter cable 4.07360.49.0. The adapter cable is sealed to protect against moisture.

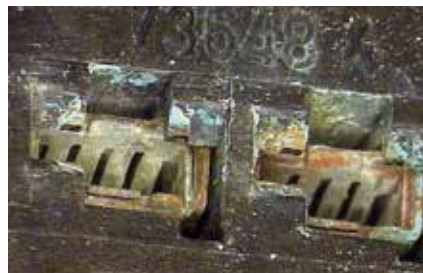
Coupling with traces of moisture and corrosion

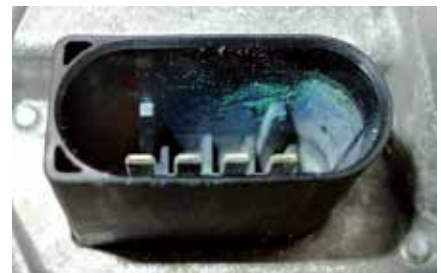
Built-in plug with traces of corrosion
