## Vacuum pump (KPSA) Piston pump with tappet drive Complaints

si 0034/A **GB**

MSI-PG 11.02

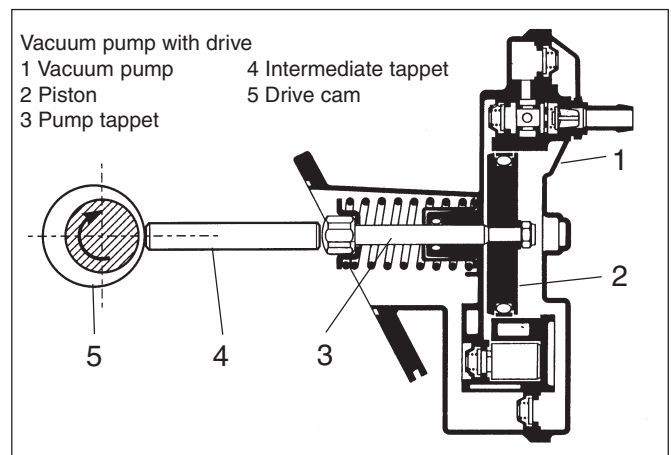
The tappet (Fig. 3) of the vacuum pump (1) is frictionally connected via an intermediate tappet (4) with the drive cam (5). As a result of excessive oil or deposits in the piston chamber, the piston stroke is limited, the tappet (3) lifts from the intermediate tappet (4) and noise occurs.

Lifting also occurs when pumps with tappets of insufficient length (incorrect assignment) are installed.

In the case of oil or deposits, the pump must be renewed. Cleaning has little point as, among other things, special tools are required and repair parts are not available.

In the case of incorrect assignment, the pump must be installed with the correct intermediate tappet.
