Technical *Info*

Installation tip for timing belt kit CT 957 K1 – WP4: e.g. Audi / VW / Skoda / Seat 1.4 / 1.6 16V

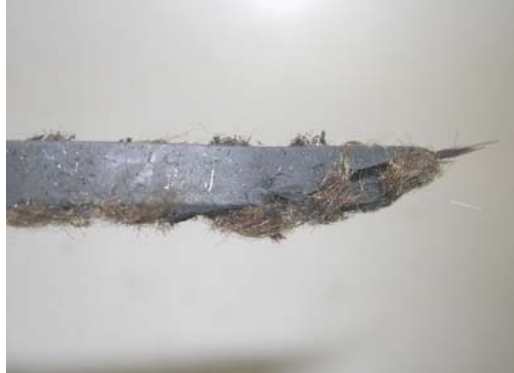
Fig. 1

The timing belt lost a great deal of its width and tore as a result. (Fig. 1)

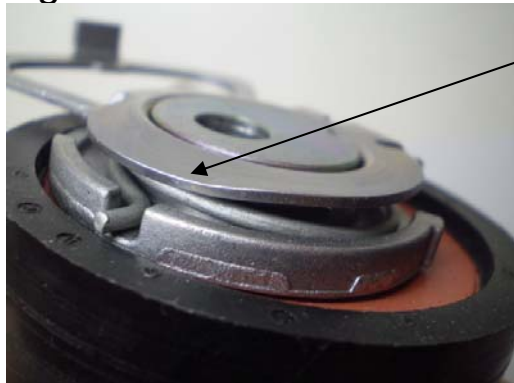
Fig. 2

The timing belt shifted to the side because of a crooked tensioning pulley. (Fig. 2)

When being tightened, the adjusting cam was **not** turned counterclockwise.
