Assembly instructions tensioning pulley 531 0402 20

Engine: 2.5 TDI

LuK AS Part No.: 531 0402 20

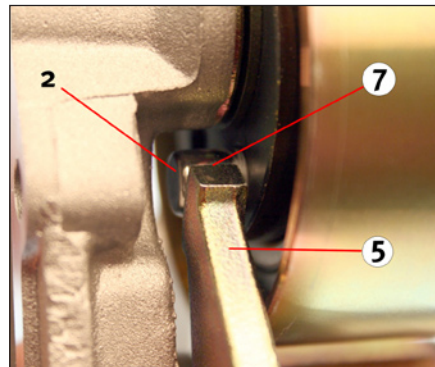
Fig. 3: Correct installation position (rear view)

Fig. 3:
The end stop (2) of the tensioning pulley runs against the contact surface (7) of the deflection lever (5).

The end stop (2) must lie on the contact surface (7) of the deflection lever (5) during installation.

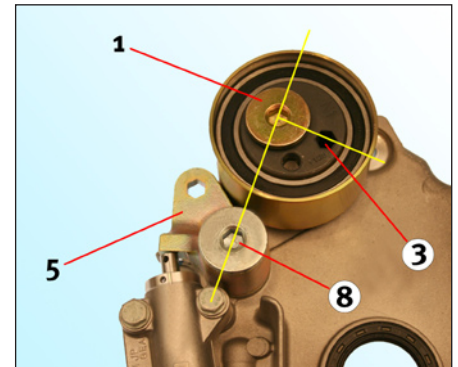
Fig. 4: Correct installation position (front view)

Fig. 4:
The hexagonal hole (3) is positioned roughly at a right angle to the axis of the bolt (1) of the tensioning pulley and the pivot point (8) of the deflection lever (5) (see yellow orientation lines).

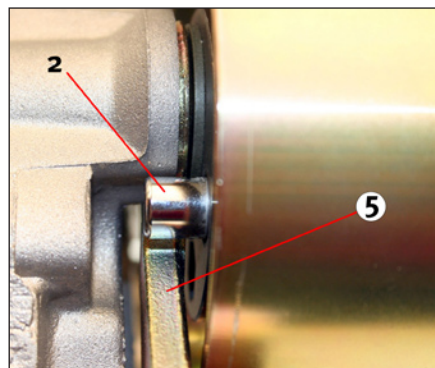
Fig. 5: Wrong installation position (rear view)

Incorrect assembly causes damage to the engine during operation! Observe the instructions from the manufacturer!

Fig. 5:
The end stop (2) of the tensioning pulley lies on the rear side of the deflection lever (5).

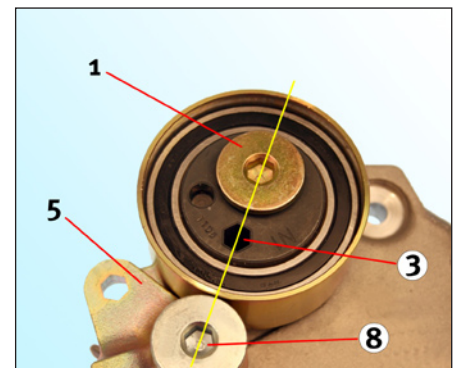
Fig. 6: Wrong installation position (front view)

Fig. 6:
The hexagonal hole (3) is positioned in a straight line to the axis of the bolts, (1) the tensioning pulley and the pivot point (8) of the deflection lever (5) (see yellow orientation lines).
