MSI-PG 02.03

Electromotive drive module (EDM-i)

Application: Tumble valve regulation

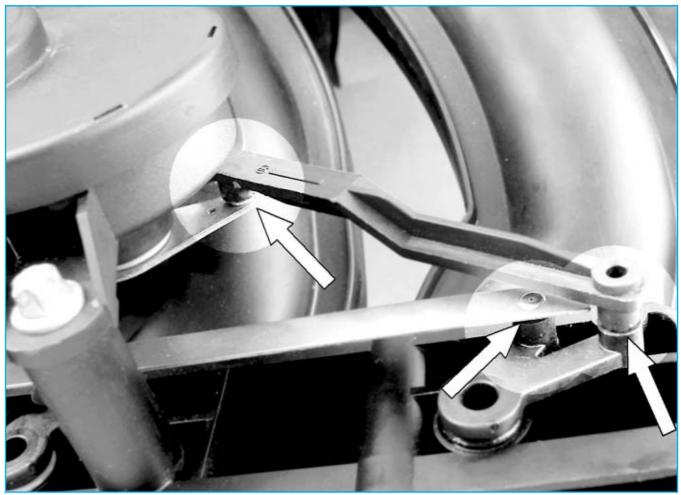
Joints between EAM-i and tumble valves

The cause is often a tumble valve that is sticking or is completely stuck.

Check the connection ("linkage") between the adjusting lever of the EDM-i and the tumble valves (see \rightarrow Fig. above).

- Check the tumble valves to ensure they operate smoothly. The adjusting lever must swing back to its start position within a period of about 1-2 seconds after making an adjustment. If this period is exceeded, an error is stored.
- Check the intake pipe for tumble valves that may be stuck.
 Deposits on the tumble valves can cause them to become difficult to move.

The cause of the deposit may be a malfunction in the injection system or too much oil in the charging air, among others. When the tumble valves are sticking, the intake pipe and AGR mixing valve must be cleaned.
