**Therefore, some febi suspension arms provide of a rubber bearing where the installation position is identified by a marking:**

**e.g. with the febi suspension arm for the Audi A 4 front axle**

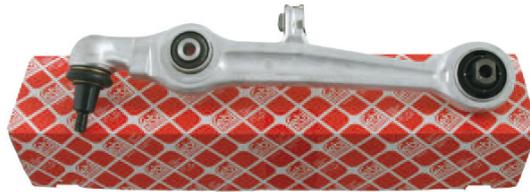
Make sure to tighten the fastening screws of the exchanged suspension arm in the deflected state in any case to avoid complaints. The tightening of the screws in the rebound state is a serious assembly error that results in an overload of the rubber bearings. This may lead to cracks that result in the premature failure of the rubber bearing. The axle geometry changes and causes additional costs (increased tyre wear!).

The marking of the suspension arm and the countermarking on the drive assembly carrier must match. Then, your customer is on the safe side!
