Technical Report #66

Failure reasons in rocker cover gasket

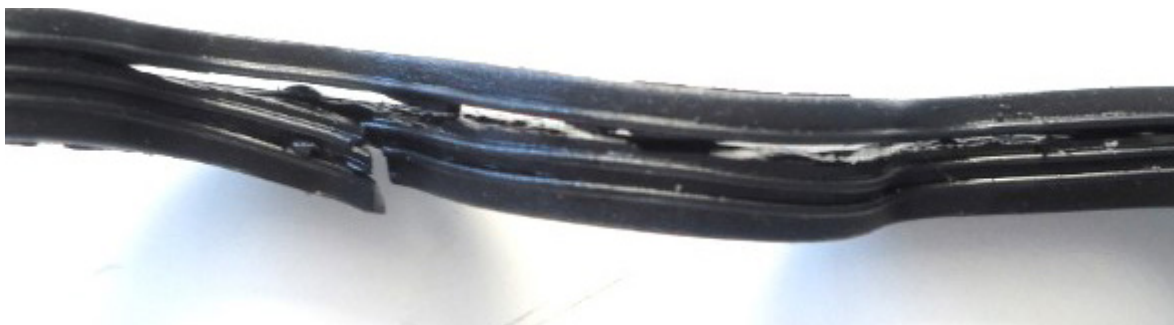
When an overpressure is applied, the material start begins to work in tensile forces and shear, for which it's not designed, ending up cracking.

In the following picture, we can see how the material has cracked due to the overpressure made by an excessive tightening:

It should be considered that the tightness of these type of gasket usually is between 8-12Nm, and if the screws are tightened without using a dynamometer, it's probable that its reaching the 25Nm easily without realizing it.

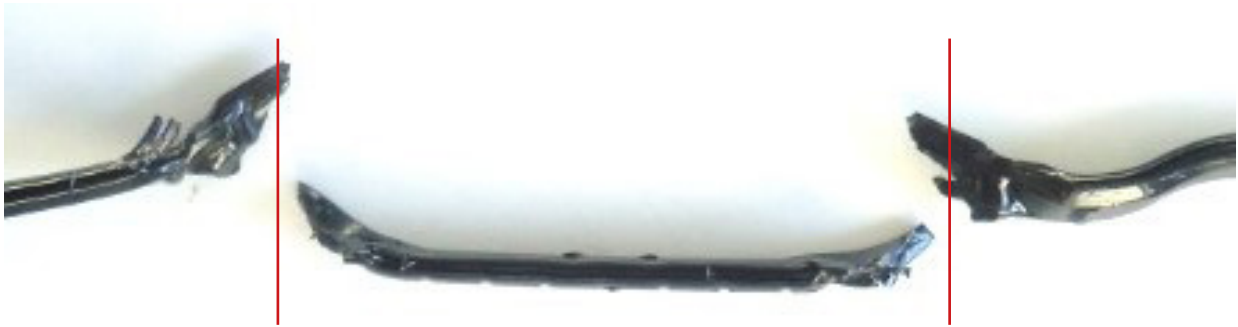
Other common fault, is to incorrectly place the gasket in its housing, so if we do the tightening processes with the gasket out of the socket, the cover would act as a shear cutting the gasket itself.

Gasket sectioned by the cover, due to improper positioning during assembly
