Control arm bushing, front axle

to fit

Mercedes W/S 210, W/S 211 (4-matic), W/S 220

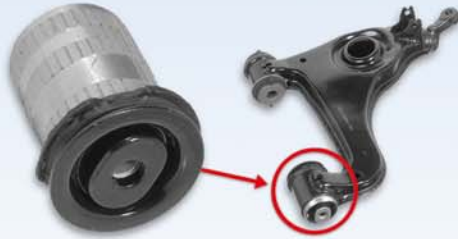
Problem

Solution
Weak sealing system of the hydro-bushing, hydraulic fluid leaks out	Replacing the hydro-bushing with a full rubber bushing
Effect	Advantage
Noise as well as reduced driving and braking safety	No more leakage, significant longer lifetime with improved driving pleasure
