# Technical *Info*

## Changes to the CT 1035 K1 / CT 1035 K2 tension pulley – Renault 1.5 dCi Nissan 1.5 dCi, Suzuki 1.5 DDIS

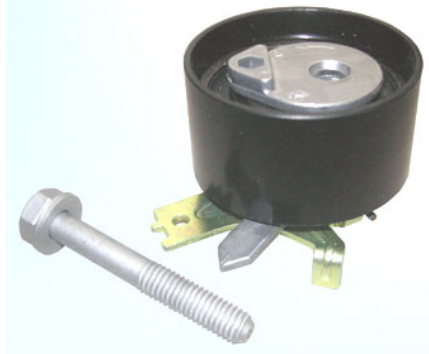
Fig. 1  
Previous design

The tension pulley supplied in the kit is designed differently from the pulley previously installed in the vehicle. (Fig.1)

Despite its different design, the tension pulley can be used for all the vehicles specified in the catalog.

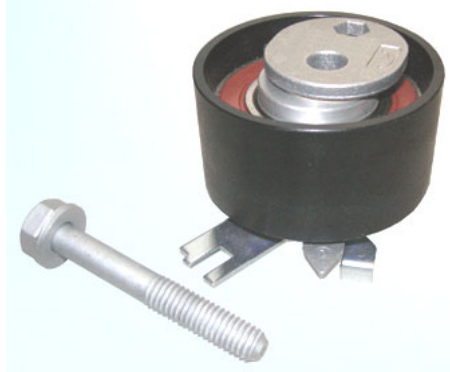
Fig. 2  
Alternative design

There is an alternative design (Fig. 2)  
This is supplied with the same screw and can be installed according to the vehicle manufacturer's specifications.

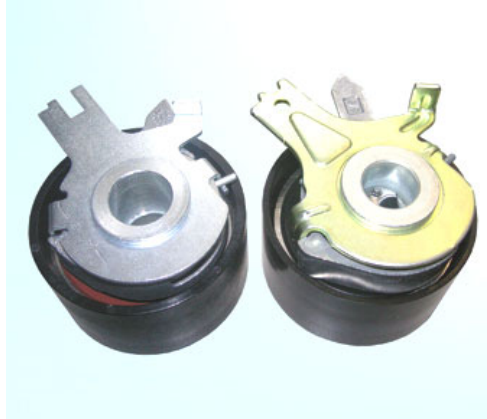
Comparison of base plates
