Technical Bulletin

Hyundai Coupe 2000-2004 - Left hand lower suspension arm modification

Application references: ADG08645

Applications: Hyundai Coupe all models 2001 > Sept 2004

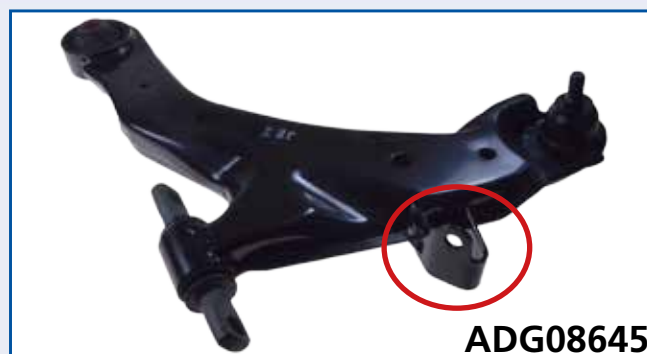
Blue Print follows the same OEM supersession as Hyundai (OEM) on the left front lower suspension arm supplied for the Hyundai Coupe. The arm is fitted with an anti-roll bar bracket which, on the Hyundai Coupe, is not required. Unless this is removed it can interfere with the operation of the suspension. The same situation arises with the original equipment component. This bracket must be removed before the arm is fitted to the vehicle.
