MEYLE ball joint repair kit: All parts easily accessible, wear and tear reduced to a minimum.

to fit Peugeot 407, 508 | Citroën C5, C6

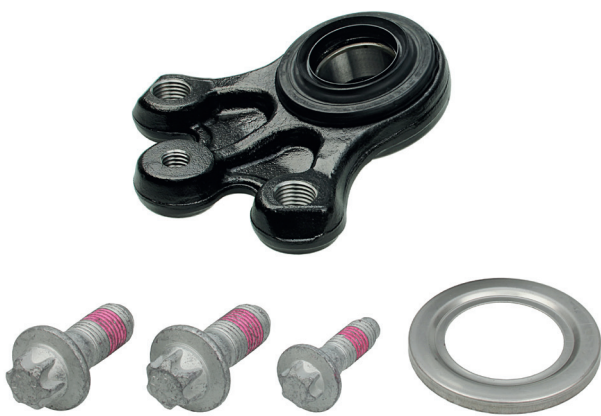
MEYLE no. 11-16 010 0018/S

- 11-16 010 0018/S [set with no guiding joint]
- 11-16 010 0019 [set with guiding joint]
