febiEXAKT

Chain Tensioner

febi no. 26751

to fit
Mercedes-Benz M271 engines

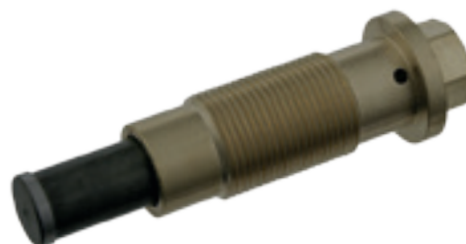
Rattling noises may occur in the area of the chain drive under certain operating conditions even though the chain tensioner and timing chain have been properly refitted.

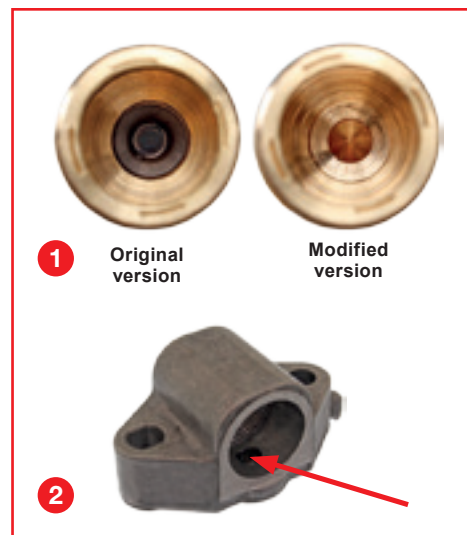
The manufacturer has modified the design of the chain tensioner. The version of the chain tensioner originally fitted (Repl. no. 271 050 04 11) has a non-return valve. In the new modified version (Repl. no. 271 050 06 11, the non-return valve has been removed (see Fig. 1).

The chain tensioner is screwed into the bracket which incorporates a non-return valve (see Fig. 2). This valve controls the volume of oil so that the piston of the chain tensioner is constantly supported by the oil pressure should the oil pressure fluctuate.

If the non-return valve in the bracket does not work correctly, the oil is always able to flow back again. As a result, the chain tensioner cannot tension the chain correctly even though the chain tensioner has been refitted. This can lead to engine damage, especially when starting up and under heavy load.

To prevent the problem described above, febi bilstein recommends that the bracket be replaced as well when the chain tensioner is exchanged for the new version. febi bilstein offers two kits (febi 40953 and febi 40954) which include the bracket with integrated non-return valve.
