Technical Report #35

*Clearance valve adjustment in 6-cylinder BMW M20(256K1)
engines*

To inform about the procedure of clearance adjustment between valves and rockers in BMW M20(256K1) engines.

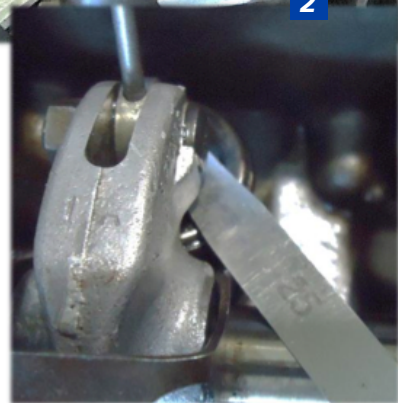
1. Loosen the fixing nut of the eccentric washer of the rocker to be adjusted.

2. Adjust the eccentric washer with the valve head by introducing between them a calibrated gauge of 0.25 mm.

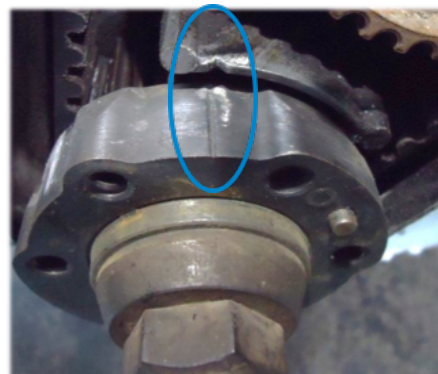
3. Once all clearances have been adjusted, turn the crankshaft 360° clockwise (to match the mark of the crankshaft pulley; the camshaft pulley will not match since it has only turned 180°).
