IMPORTANT INSTALLATION NOTICE

Automatic transmission filter with oil pan

8020015 and 8020016

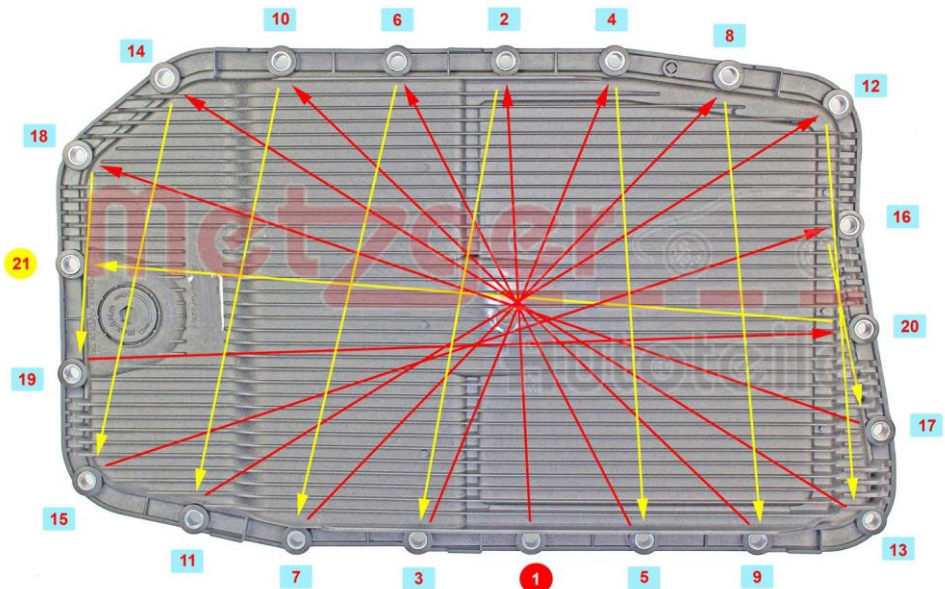
Upright mounted oil pans cause oil leaks and cracks in the oil pan itself. **Note the tightening sequence during installation!**

Tightening sequence: Keep oil pan on the gearbox and screw all screws in by hand. Check correct fitment of the oil pan. Start fasten screws at position 1 crosswise from inside to outside. Torque 10 NM. The car manufacturer's instructions must be observed.
