## Complete cardan shaft change to replace defective centre bearing? – Not with MEYLE!

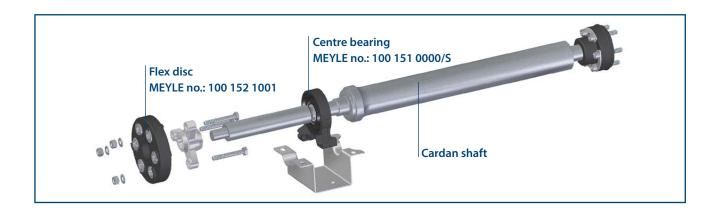
The MEYLE centre bearing repair kit offers a swift, cost-effective alternative paired with unproblematic replacement. The kit includes the bearing, rubber boot, clamp ring and grease complemented by step-by-step fitting instructions to ensure full-service repair.

MEYLE no.: 100 151 0000/S	Centre bearing repair kit
	MEYLE no.: 100 152 1001	Flex disc repair kit
		incl. mounting material
	MEYLE no.: 100 152 2001	Full-service cardan shaft repair kit
		incl. mounting material

To avoid repeated repairs and additional costs always replace the flex disc along with the centre bearing. It's just as easy with the MEYLE repair kit 100 152 1001 containing the flex disc and corresponding mounting parts.

The MEYLE repair kit 100 152 2001 which includes the centre bearing, flex disc, stretch bolts and mounting parts.
