SERVICE INFO

Risk of confusion between tensioning pulleys 531 0252 30 and 531 0525 30

Issued 03.2011

INA 0069

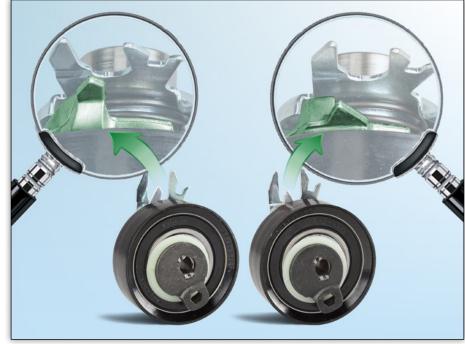
Image: Distinguishing between tensioning pulleys 531 0252 30 (left) and 531 0525 30 (right)

There is a risk that tensioning pulleys 531 0252 30 and 531 0525 30 could be confused with one another.

Not only are the item numbers very similar, there is very little to differentiate the devices from a visual perspective.

Only the pointers of the two tensioning pulleys and the alignment of the pointers (see image) is different.

However, from a technical perspective, the two devices are very different. Tensioning pulley 531 0252 30 has a higher tensioning force and a larger operating range than tensioning pulley 531 0525 30.

Interchanging the tensioning pulleys could lead to oscillation, thereby causing the toothed belt to skip. It could even result in damage to the engine.

Before installing the tensioning pulleys, it must be ensured that the part number is correct. The similarity of the numbers means there is an increased risk of confusing these two components.

Note the specifications of the vehicle manufacturer!
