Electric EGR valves

Matching to the engine controller is required

Vehicle	Product	PIERBURG No.	O.E. No.*
various VW, Seat, Skoda, Audi	Electric EGR valve	7.22574.11.0; 7.28070.02.0; 7.22785.11.0/.12.0/.13.0/.14.0 7.28248.16.0	see catalogue/TecDoc CD

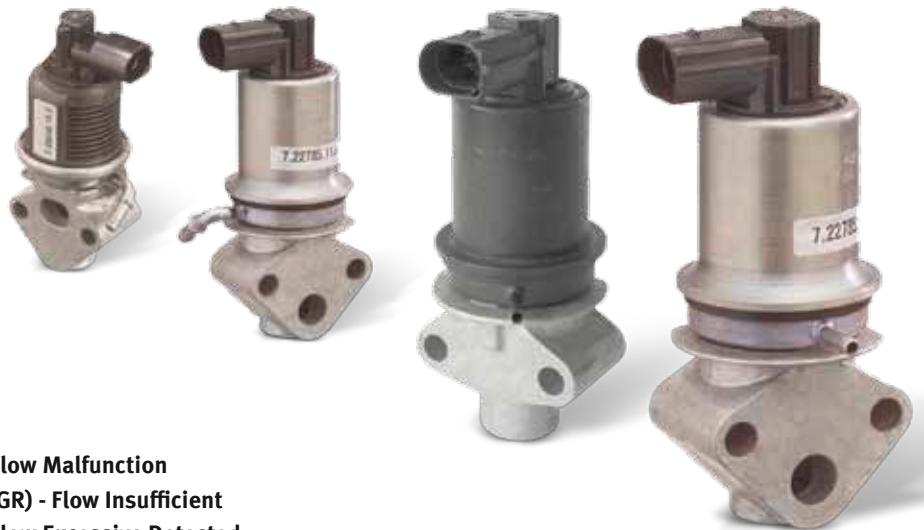
Different electric EGR valves

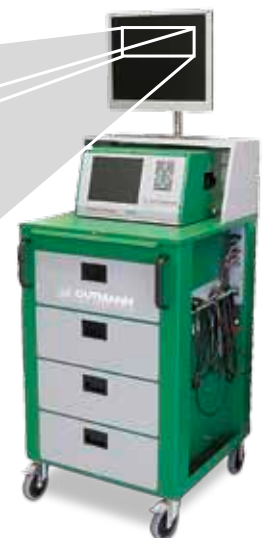
Basic adjustment	
Adaption throttle body control unit	MO
Check Lambda Converting Bank 1	MO
Adaption EGR valve	 MO
Reset gear data	GE

*Output for EGR valve matching
(Gutmann engine tester, for example)*

The electric EGR valve must be adapted to the engine controller!

This is done by selecting a special programme of the engine tester (“default setting”, for example).
